Boone County Fairgrounds— Site and Space Analysis

Prepared by: The Department of Parks, Recreation and Tourism
University of Missouri - Columbia
September 2001

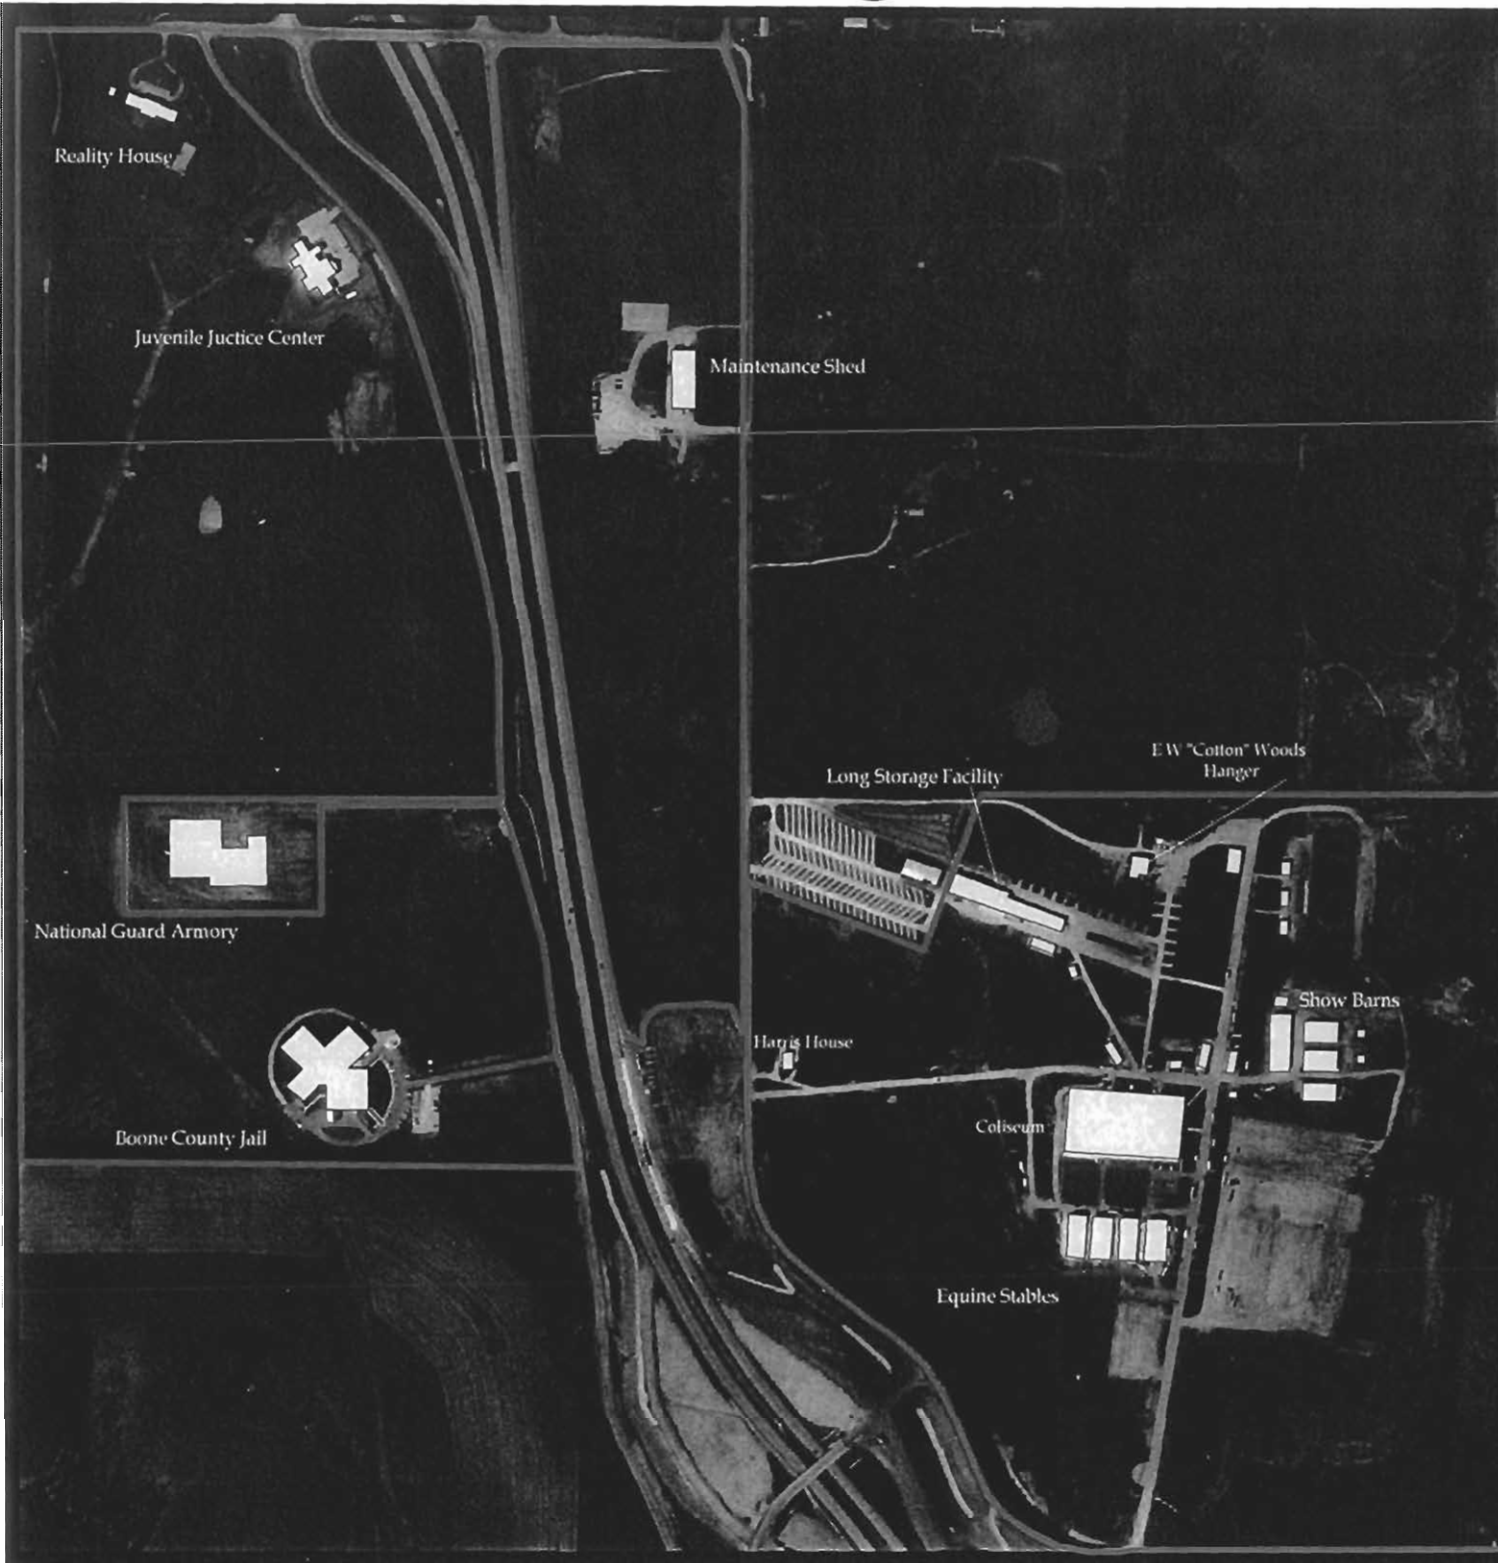
Buildings

Structures were constructed using GPS receivers and GIS digitizing
Dimensions of the buildings are located in the preceding document

There are a number of structures (21) within the Boone County Fairgrounds. Many are special purpose type buildings in that they are used on a limited basis throughout the year. Several are related to livestock housing and show (9). Three buildings support the Special Events Track as restrooms and concessions. There are four buildings used specifically as equine stables. Four buildings provide concessions during the fair week. Some buildings are remnants of the Cottonwoods Airpark and are not integral to the operations of the fairground property. For example, the main hanger and office area provide storage for a variety of items including an old car, trailer and during the period of this study, a dog pen. Much of the interior is poorly maintained. In addition, the hangers located near the Cottonwoods RV Park are also poorly maintained, but do store some items germane to the operation of the fair. A portion of these hangers housed the old fairground office. This area is now an office for Balloon Stormers. Cottonwoods RV Park rents the southern section of the building as a meeting room. The multi-purpose coliseum, however, provides use opportunities on a regular schedule most weekends during the year. We have provided building sizes and square footages.

All buildings for the surveyed area were visually located and digitized using aerial images. Building lengths and widths were collected from previous building inventories. Heights were determined from two-foot intervals from the ground to the roof peak. These figures are included in the data files associated with the building of a Geographic Information Systems (GIS) layer. The data file also contains a Global Positioning System (GPS) generated corner for each building to verify the location.

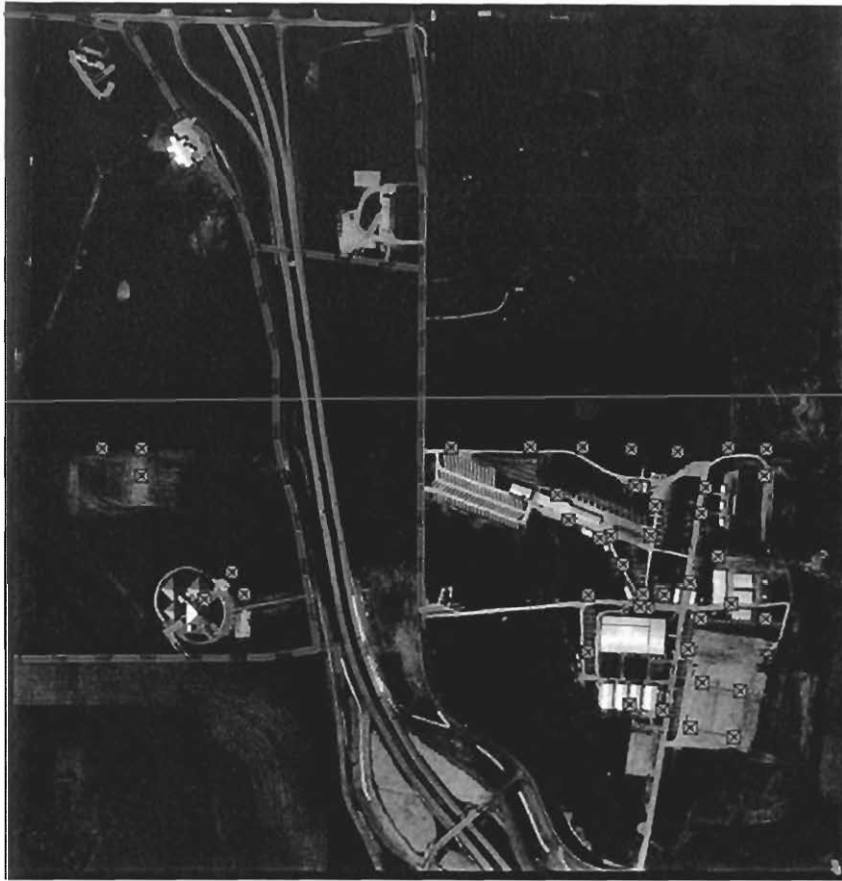
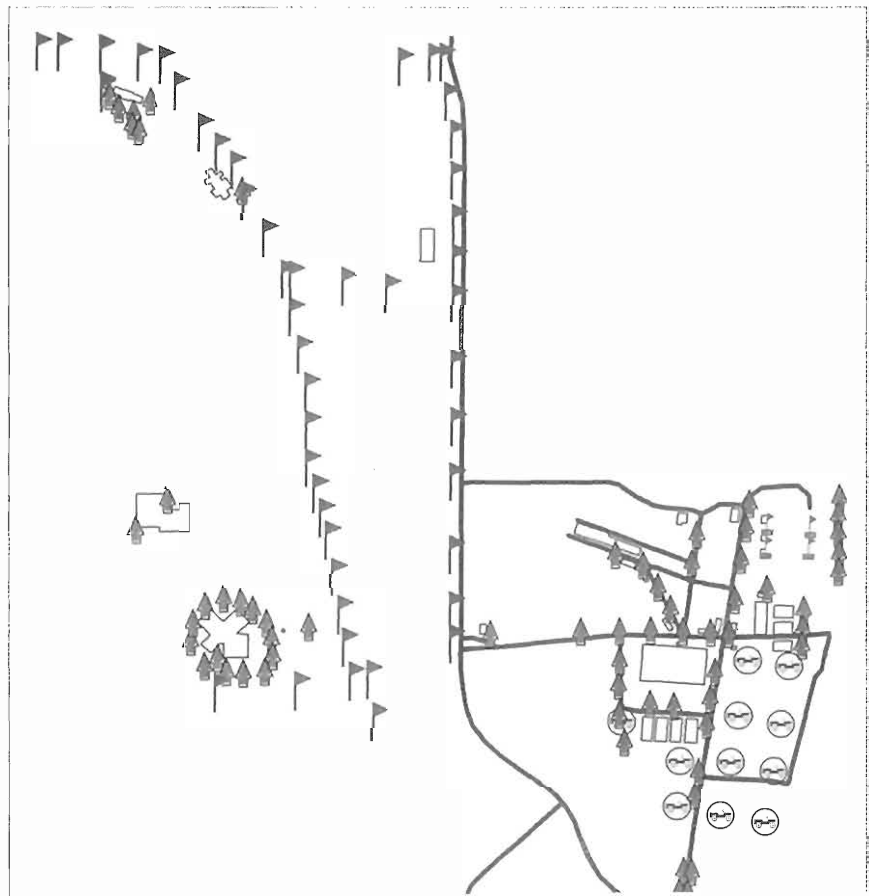
Aboveground Electric

All existing overhead electrical lines were visually located and verified. The majority of these locations occur south of Highway 63. Few overhead utility lines exist on the fairground property. Lines that attach to the buildings are secondary lines. The lines that cross Highway 63 east of the Boone County Maintenance facility intersect lines that run along Roger Wilson Memorial Drive. These are referred to, as are primary lines.

Within the fairground property there are very few overhead utility lines. The line located to the east of the outdoor arena was placed after an underground electric line failed. Another line runs from the Coliseum to the Optimist concession and then to the Show Palace. Within that overhead lines are telephone connections for the Optimist concession and communication cable (speakers) for the Show Palace. From the Optimist concession to the Show Palace the line run underground.

The only other line located above ground is from the old fairgrounds office to a pole located west of the Coliseum. This line is not in operation and was placed for use during the National Balloon Festival.

The lighting in the area was also located by visual inspection. For the most part, the lighting is standard street type light poles/fixtures. Within the fairgrounds the lighting varies to provide lighting in the parking lot and stadium lighting.

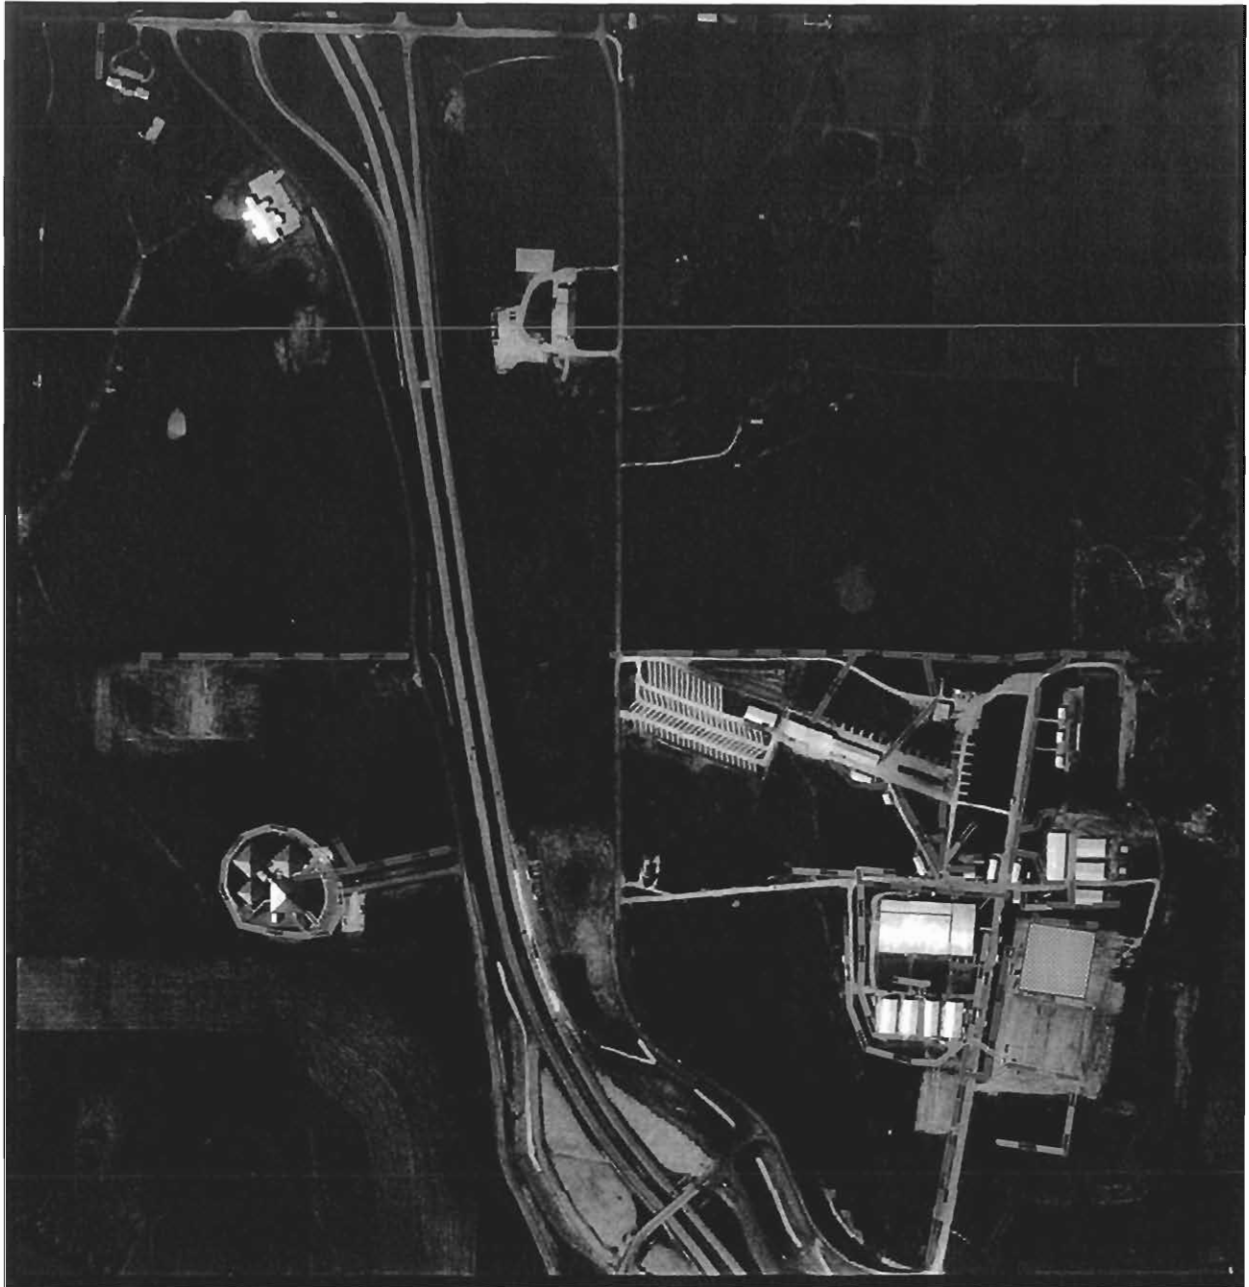
Underground Electric

The underground electrical lines within the fairground property represent the largest encumbrance of open space. The placement of underground utilities from a visual viewpoint is a benefit. The negative for this site is any development that may occur in the future could impact existing underground electric utilities. In some areas there are underground electric lines that feed light poles as secondary services that are in close proximity to primary lines. This congestion increases the difficulty of any development near these lines. The RV hook-ups also consume a considerable portion of the largest parking lot and any open space west of the coliseum. Generally, the only areas that are not crisscrossed by underground electric lines are the areas south of Bear Creek, north of the livestock barns and north of the parking lot.

Boone Electric Cooperative (BEC) provided both a map (attached) and GPS locations of all transformers and poles, but provided a map only for underground lines. Underground lines were located either visually by observing the ditch line (disturbed area) or using triangulation based on known points and the required straight lines to connect the points.

The ground source heat pump loops were also located on the maps provided by the Boone County Electric Cooperative. Using computer-generated points, the location of the ground source heat pump is provided. It was not possible to visually locate the location of the loops.

Boone County Electric Cooperative assisted in locating all underground sources.

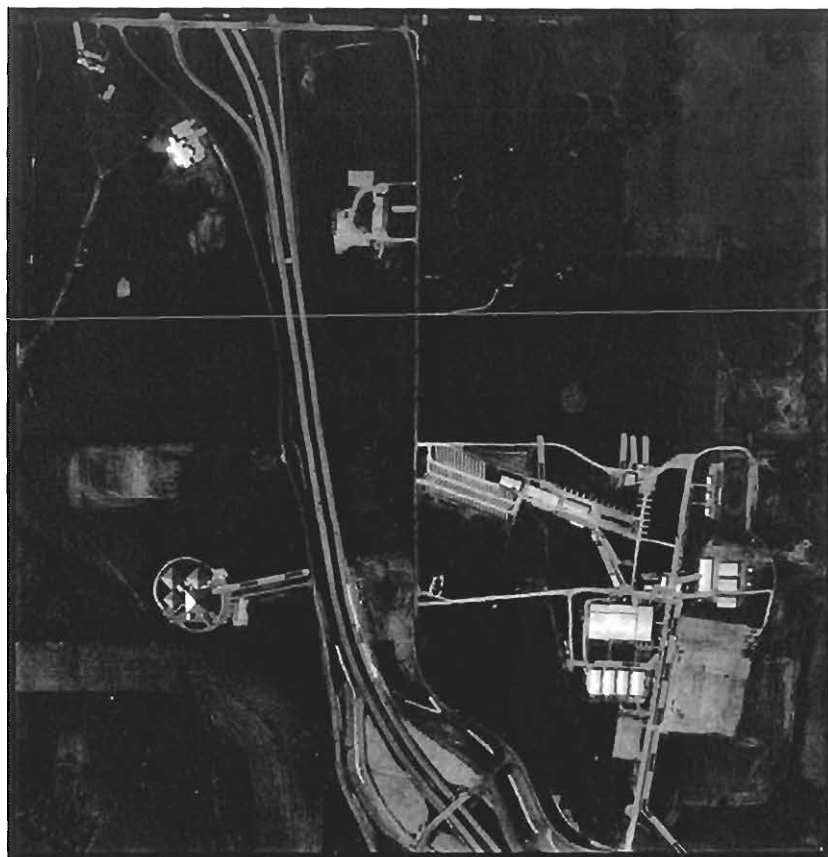
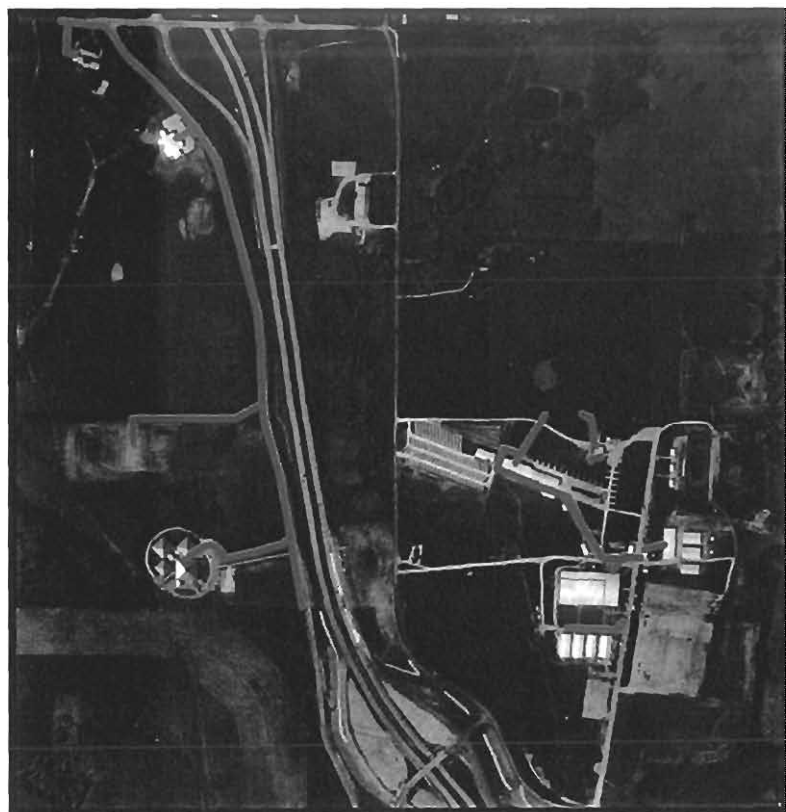
Telephone Lines

The overhead telephone lines were visually located. The overhead lines are the only three overhead utilities in the fairgrounds area. They were installed for communication purposes within the fairgrounds. The northwestern line is currently abandoned. All three lines are within ten-meter accuracy.

Underground telephone lines were identified after meeting with Verizon officials and reviewing their maps. These maps are not available for distribution and therefore are not included as an attachment. Again, SM&P provided the physical location of all the underground telephone lines. Immediately afterwards, the lines were logged using GPS receivers and recorded for permanent storage. Large cables (multiple pairs) were also located based on utility pedestals. Much of the telephone service comes from the western edge of the fairground property. For properties south of Highway 63, the telephone cables lay along the southern edge of Roger Wilson Memorial Drive. All buildings on those county parcels are serviced with underground telephone cable.

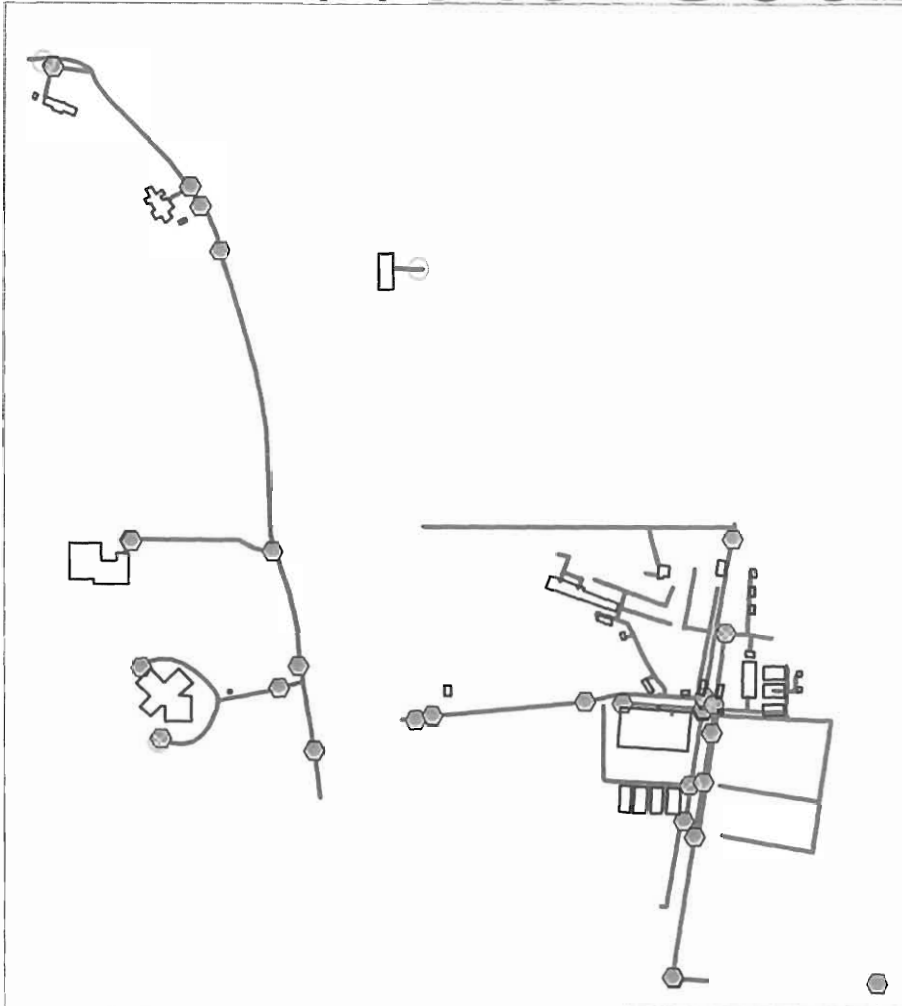
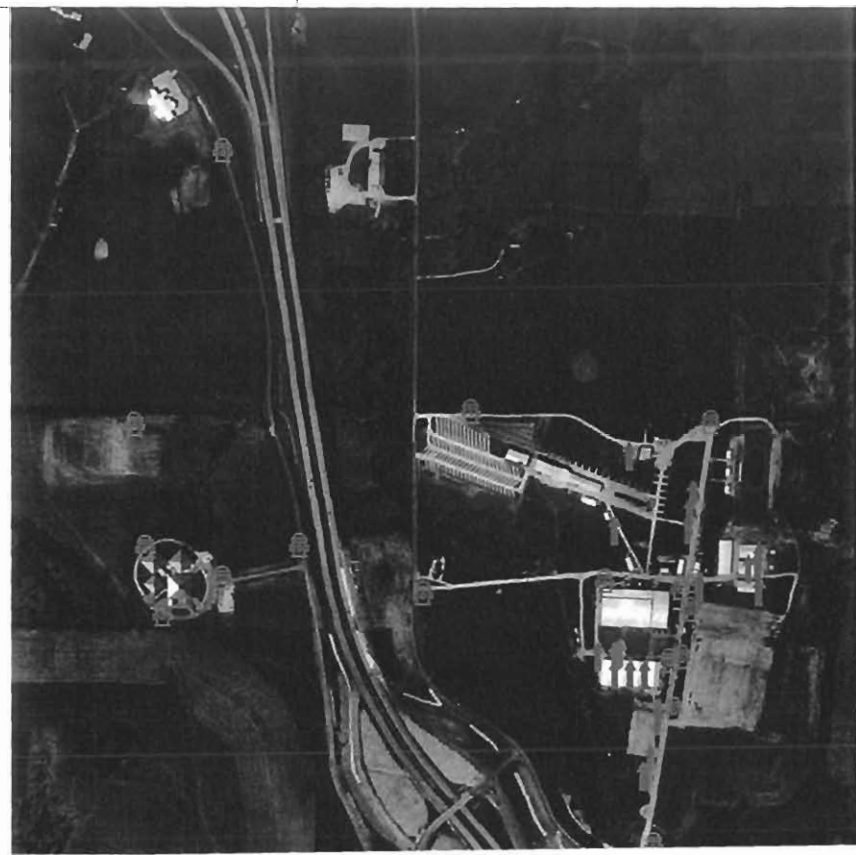
Water Sources

Water lines within the fairground property are under the jurisdiction of the City of Columbia. With their help the water lines were located. Two lines feed the fairground. One enters from the west along the southern edge of the main drive (Coliseum Boulevard) and the other is along the western edge of the gravel service road that exits south of the fairgrounds.

The property is divided into four quadrants for distribution of water. The intersection of this quadrant is the main road and the north south gravel road to the livestock barns. Each quadrant has a 2” meter that is surrounded by a steel guardrail. The northwest quadrant has a meter located just south of the Youth Building (Shower house) that provides water for the Special Events Arena and associated concession buildings, restrooms and the Youth building. A meter located just south of the Helen Beckett 4-H Foundation building serves the northeast quadrant. This meter provides water to the Show Palace (disconnected and buried), the livestock barn and the wash-down area. This meter also provides the water to all the RV hookups in the main parking lot. A meter located just north of the equine stables services the southeast quadrant. This meter provides water for the stables and the tank fill valve located just south of the stables. The last meter is located in front of the Pork Producers concession. This meter provides the greatest share of water to the fairground property. The Coliseum and all buildings west of the coliseum are serviced from this line.

Water for the old hanger and airpark office comes from the property line to the west. The water for the old fairground office and the hanger comes from a line located on the Cottonwoods RV park property.

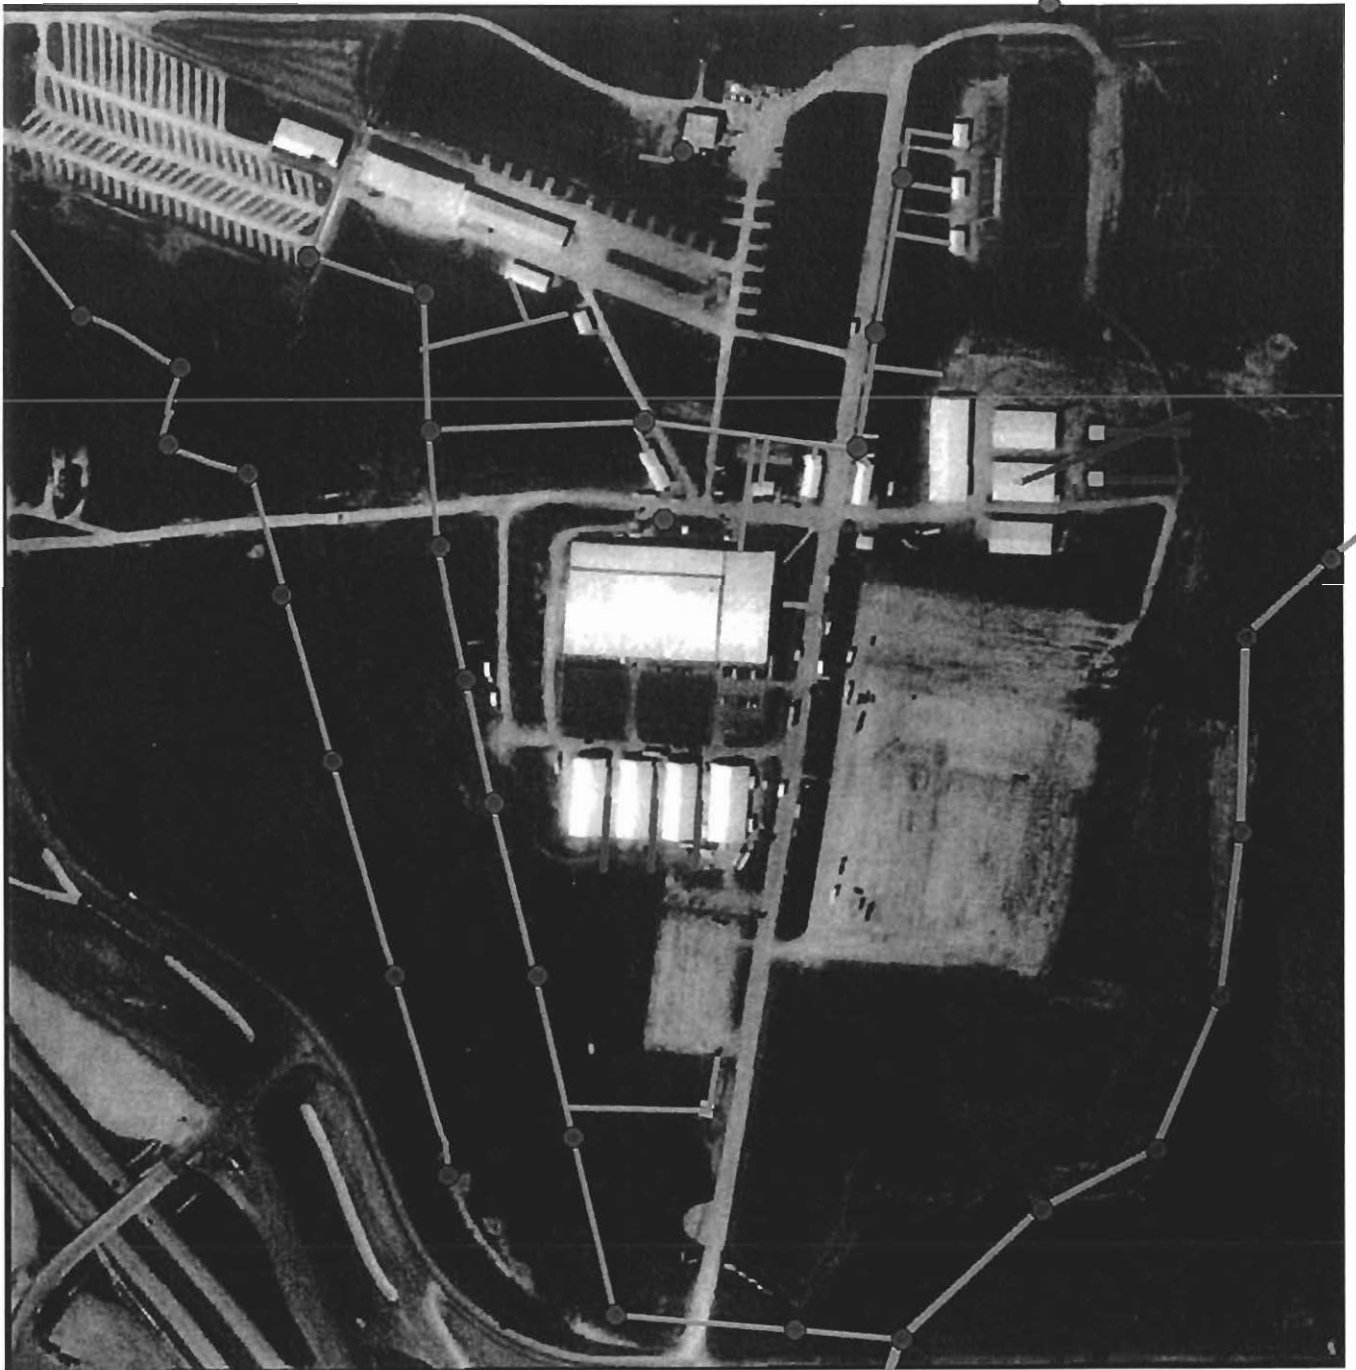
Sewer & Drainage

The sewer lines were located by maps and information provided by the Boone County Regional Sewer District, the City of Columbia and Elra Sapp. Sewer mains were located visually and by locating the sewer manholes and identifying the routes that connect the manholes. Most of the lines had some type of disturbance of the soil overhead and were not difficult to locate. Others required our asking the original contractor to come on site and make the location for us.

Lateral connections to buildings from the main sewer lines were more difficult to locate. Some laterals were visually located, but others required a determination of the most obvious route to the building. The only buildings that were unclear even after having the original contractor on site were the Elks concession and the southernmost restroom building near the Elks concession. Most buildings have some type of clean-out near the building that identified the placement of the sewer. Other buildings required our entry to determine the likely point of entry for the sewer lateral.

Second, only to the underground electric, the sewer lines encumber a considerable portion of the property by a sectional transverse of the three largest open areas of the fairgrounds. There are sewer lines located north of the parking lot across the rugby field, south of Bear creek through the open space between the creek and Oakland Gravel road and east of the Cottonwoods RV Park. The latter, transverses northeast across the open space southwest of the Coliseum, and then across the service road toward Starke Lane immediately south of the Coliseum. From an open space perspective, few areas exist that are not encumbered by one or another form of underground utility. As is the case with

underground electric lines, any development over these sewer lines may require relocation at substantial expense.

In several places there are also drainage lines that are not attached to any sewer line. These are located north of the livestock barns as an animal wash-dawn area and east of the stables. Three lines exit between the stable buildings and flow upon the ground. These locations were determined visually by noting the point at which the water ran out of the pipes. This wastewater eventually enters Bear creek.

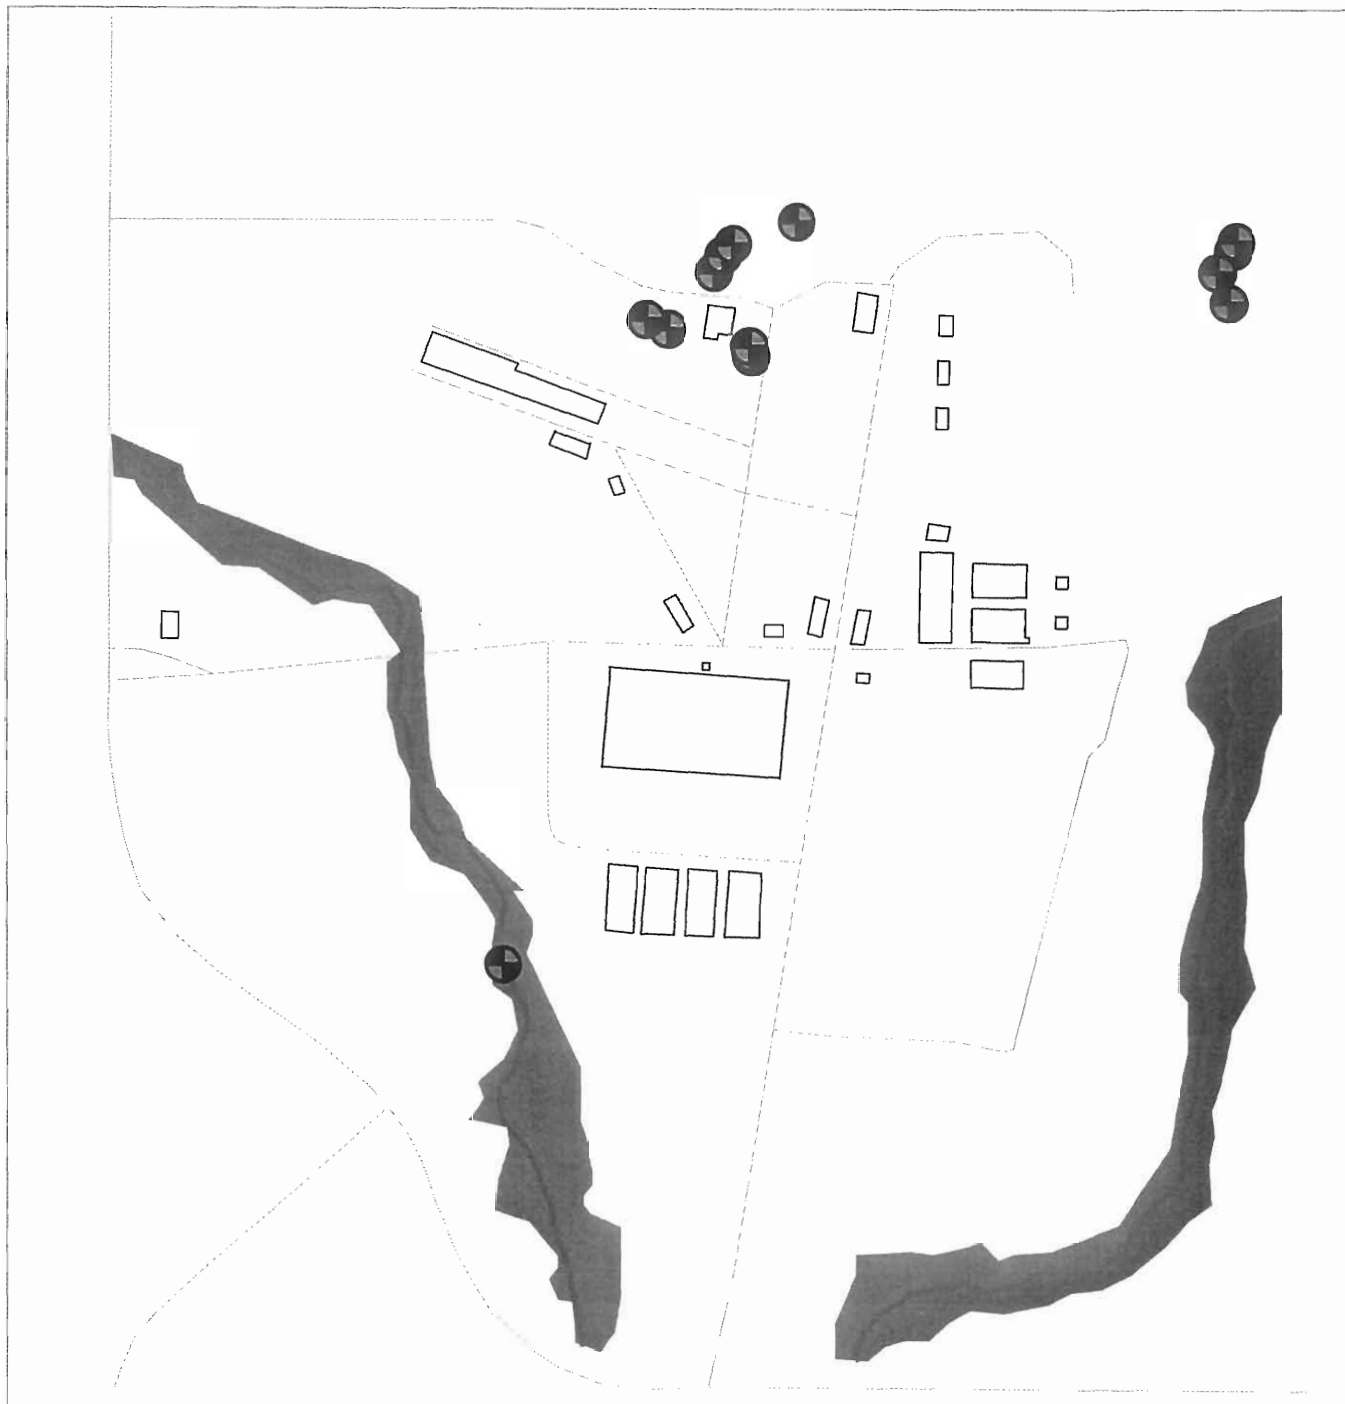
Waste Sites

Throughout the fairground property a variety of discarded materials exist. Most of these materials would not be considered hazardous waste, however, a professional verification should be done to confirm the existence of any hazardous waste. For example, there are several piles of waste located in the northeast corner of the property that appear to have increased over the years. These areas tend to attract more refuse rather than degrading themselves. There are also various disposed items located along the western edge of the property near the old hanger. Most of these do not support the operations of the fairgrounds. Surrounding the hanger, there are also several items that may have been used at one time or another. These items have not been moved in several years. Items within the building also require inventory to determine their relationship to the fairgrounds. Several trucks and pieces of equipment are located behind the former fairground office along with discarded materials that also need to be inventoried.

Another item that could be determined as hazardous waste are the piles of livestock manure. Much of this is equine related and located near the stalls. It appears that over the years much of the waste has been piled up near the buildings as a matter of convenience and proximity. These piles of sawdust and manure may have been created assuming they would decay over time. This unfortunately has not occurred. The continual placement of new waste compacts the piles so air can no longer reach the center of the piles to assist in the decomposition process. These piles should be leveled to promote their breakdown.

Another area that should be addressed is the placement of equine waste in Bear Creek. At the time of the on-sight study, the waste was notable. Recent verification has not been made to determine if the practice is continuing.

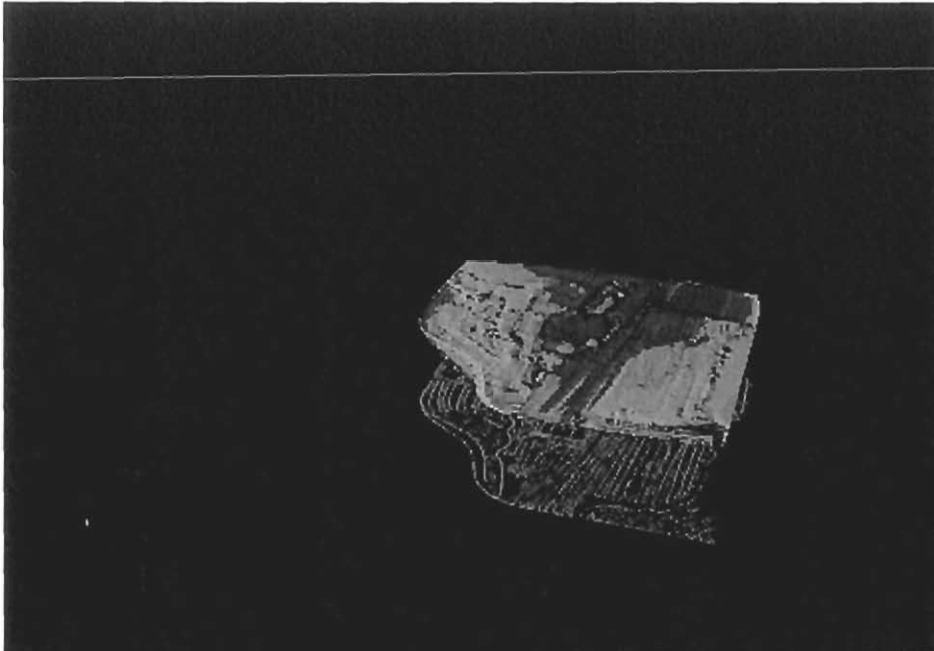
Contours

Depictions of 3D models are provided. With the typical gentle slope of this type of topography, variations are slight. Further modeling may be done by the county with the provided data set. The data set is provided.

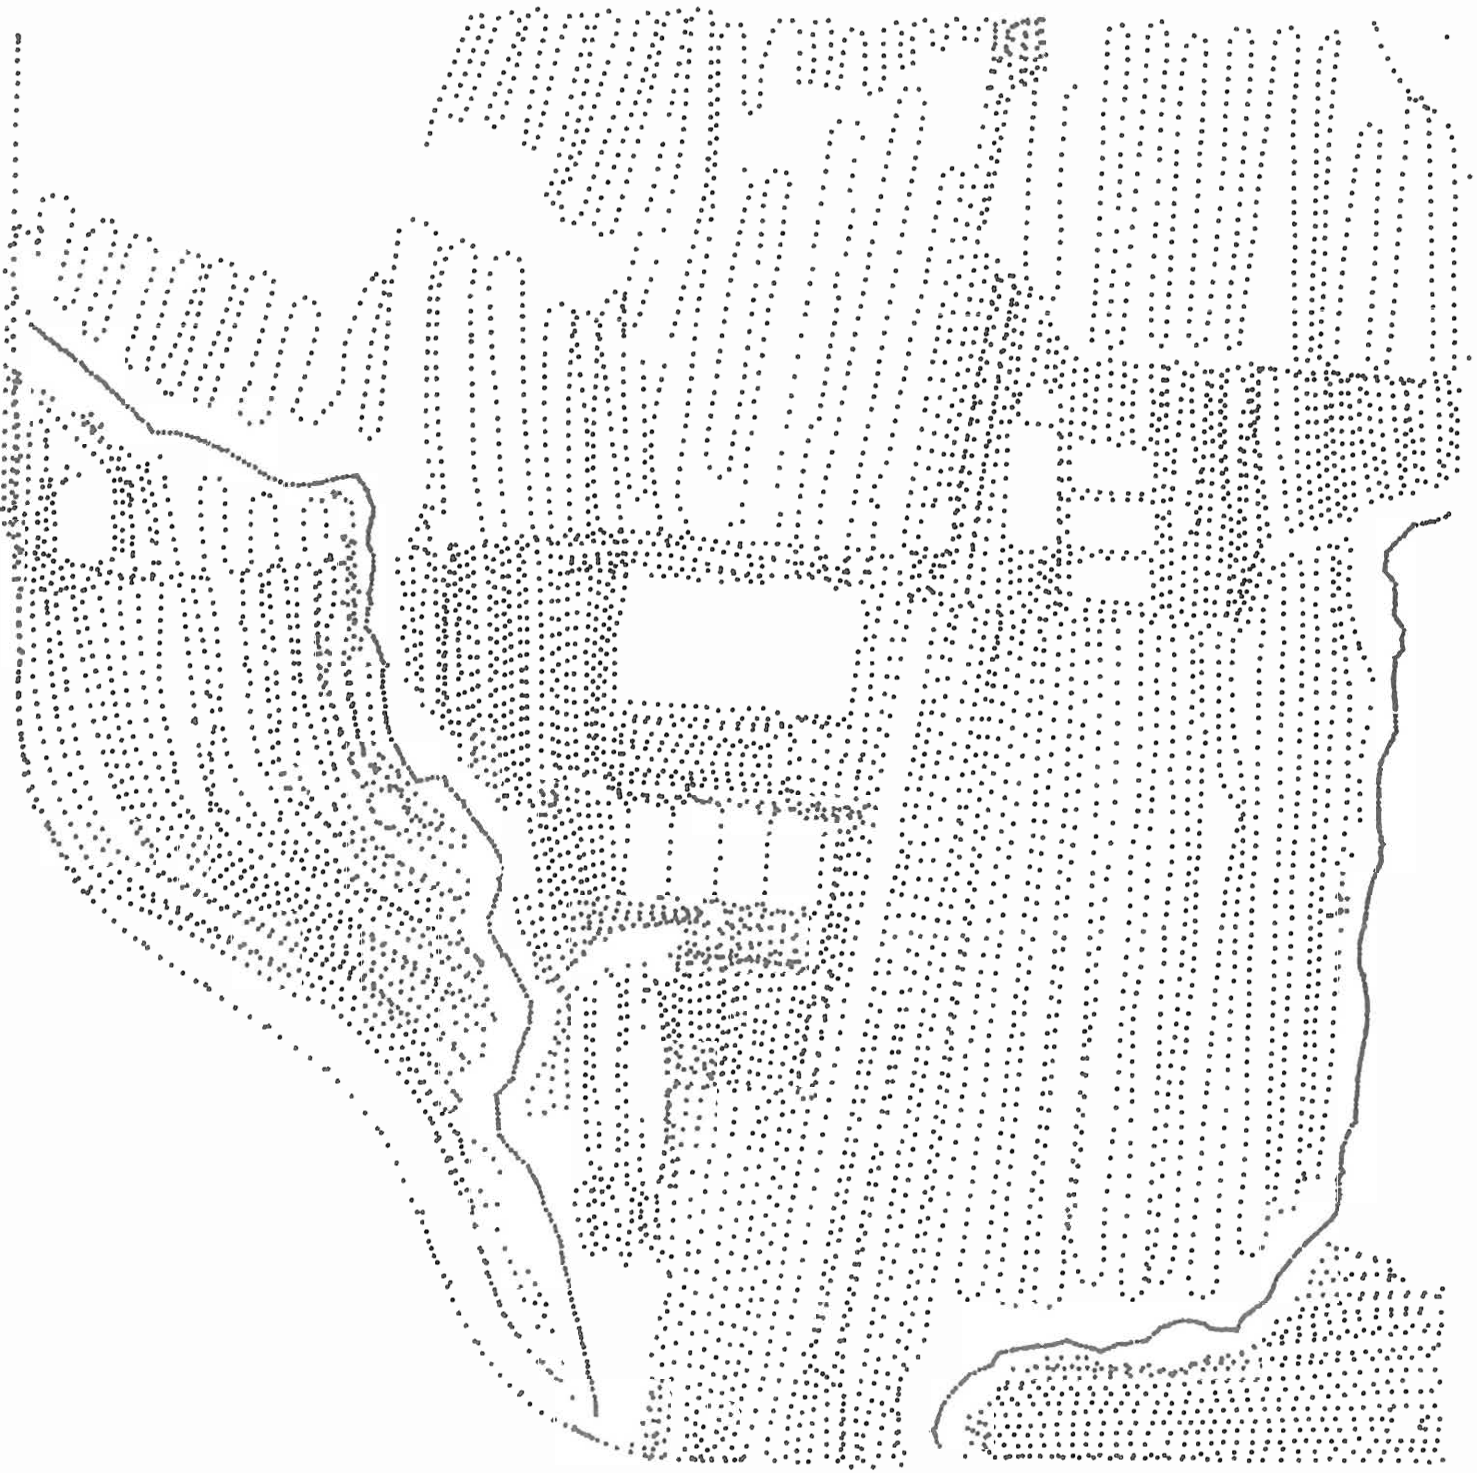
Contour points represent data collected on elevation in the fairgrounds site only. 3D models can be generated in the ArcView GIS program.

Contours were created at 50 meter intervals.
